The Decision to Launch the Space Shuttle Challenger

ON JANUARY 28, 1986, the space shuttle Challenger exploded and seven astronauts died because two rubber O-rings leaked.²² These rings had lost their resiliency because the shuttle was launched on a very cold day. Ambient temperatures were in the low 30s and the O-rings themselves were much colder, less than 20°F.

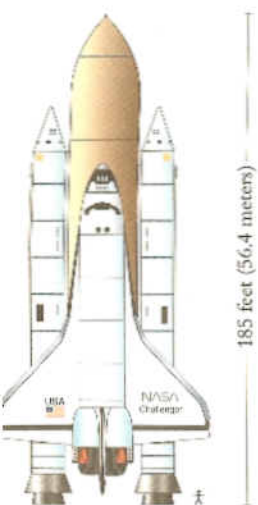
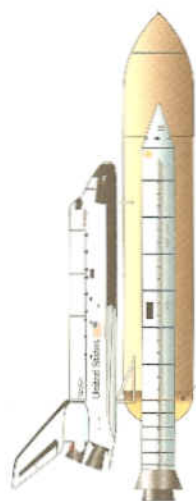
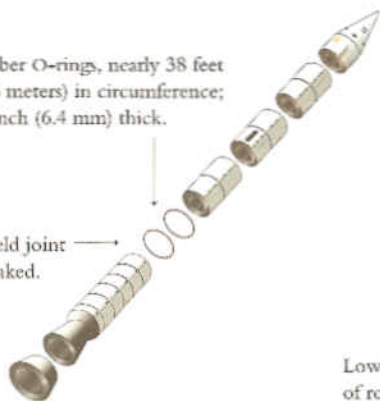
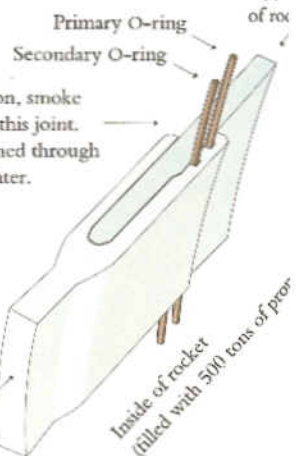
The field joint that leaked.

Rubber O-rings, nearly 38 feet (11.6 meters) in circumference; 1/4 inch (6.4 mm) thick.

Upon ignition, smoke leaked from this joint. A flame burned through 59 seconds later.

Exterior wall of rocket
Lower segment of rocket casing

The shuttle consists of an orbiter (which carries the crew and has powerful engines in the back), a large liquid-fuel tank for the orbiter engines, and 2 solid-fuel booster rockets mounted on the sides of the central tank. Segments of the booster rockets are shipped to the launch site, where

they are assembled to make the solid-fuel rockets. Where these mate, each joint is sealed by two rubber O-rings as shown above. In the case of the Challenger accident, one of these joints leaked, and a flame burned through the side of the booster rocket.

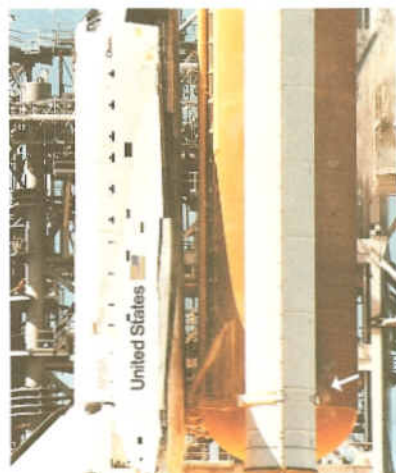
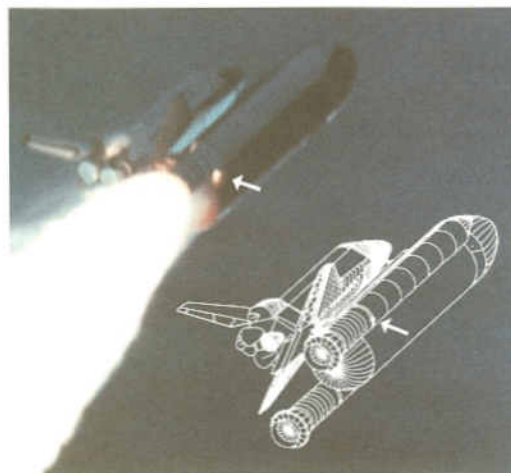
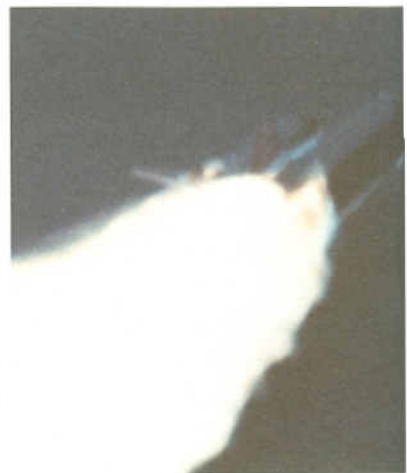
Less than 1 second after ignition, a puff of smoke appeared at the aft joint of the right booster, indicating that the O-rings burned through and failed to seal. At this point, all was lost.

On the launch pad, the leak lasted only about 2 seconds and then apparently was plugged by pyrotechnics and insulation as the shuttle rose, flying through rather strong cross-winds. Then 58.788 seconds after ignition, when the Challenger was 6 miles up, a flicker of flame emerged from the leaky joint. Within 10 seconds, the flame grew and engulfed the fuel tank (containing liquid hydrogen and liquid oxygen). That tank ruptured and exploded, destroying the shuttle.

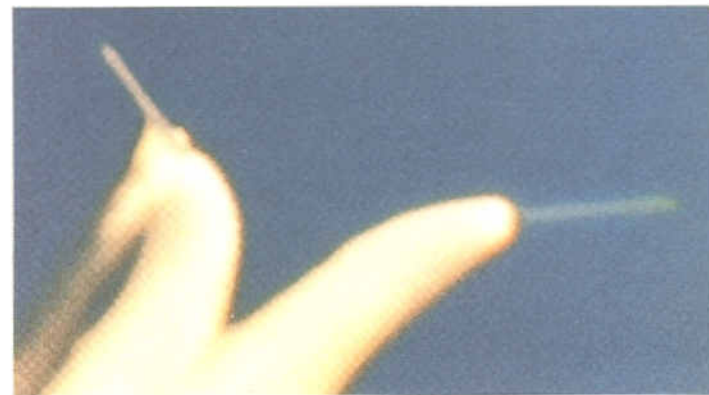
As the shuttle exploded and broke up at approximately 73 seconds after launch, the two booster rockets crisscrossed and continued flying wildly. The right booster, identifiable by its failure plume, is now to the left of its non-defective counterpart.

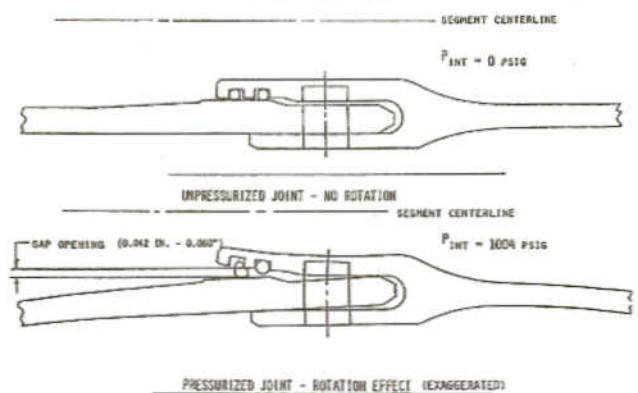
BLOW BY HISTORY

SRM-15 WORST BLOW-BY

- o 2 CASE JOINTS (80°), (110°) ARC
- o MUCH WORSE VISUALLY THAN SRM-22

SRM 22 BLOW-BY

- o 2 CASE JOINTS (30-40°)

SRM-13A, 15, 16A, 18, 23A 24A

- o NOZZLE BLOW-BY

Two charts further narrowed the evidence. Above left, "Blow-By History" mentions the two previous launches, SRM 15 and SRM 22, in which soot (blow-by) was detected in the field joints upon post-launch examination. This information, however, was already reported in the more detailed damage table that followed the title chart.³⁰ The bottom two lines refer to *nozzle* blow-by, an issue not relevant to launching the Challenger in cold weather.³¹

³⁰ On the blow-by chart, the numbers 80°, 110°, 30°, and 40° refer to the *arc* covered by blow-by on the 360° of the field (called here the "case") joint.

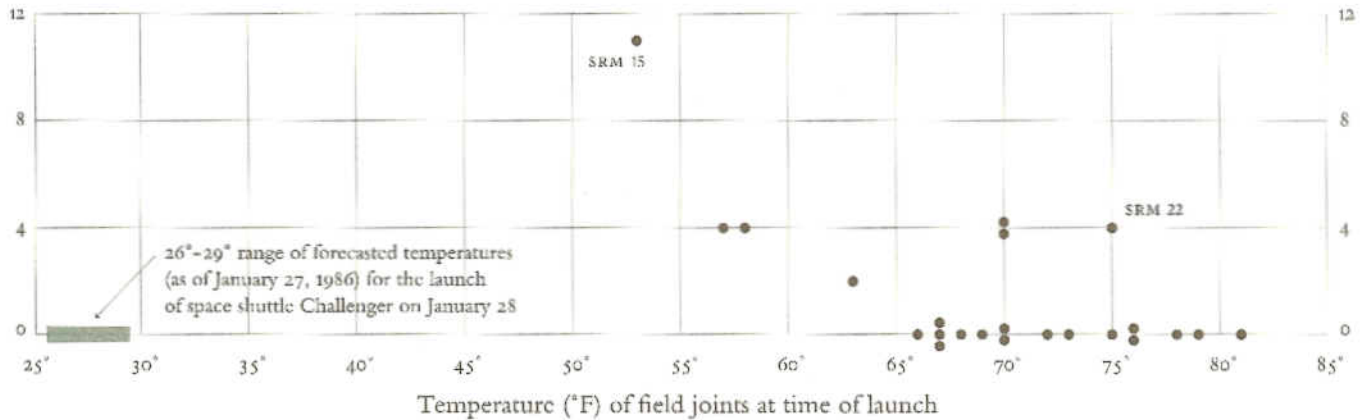
O-ring damage
index, each launch

Above, a scatterplot shows the experience of all 24 launches prior to the Challenger. Like the table, the graph reveals the serious risks of a launch at 29°. Over the years, the O-rings had persistent problems at cooler temperatures: indeed, *every* launch below 66° resulted in damaged O-rings; on warmer days, only a few flights had erosion. In this graph, the temperature scale extends down to 29°, visually expressing the stupendous extrapolation beyond all previous experience that must be made in order to launch at 29°. The coolest flight without any O-ring damage was at 66°, some 37° warmer than predicted for the Challenger; the forecast of 29° is 5.7 standard deviations distant from the average temperature for previous launches. This launch was completely outside the engineering database accumulated in 24 previous flights.

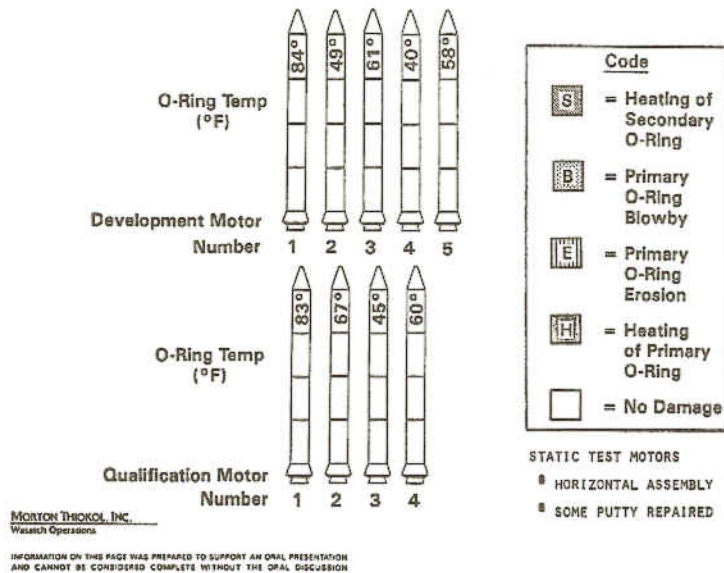
History of O-Ring Damage in Field Joints

Prepared for testimony to the commission, the chart above shows nine little rockets annotated with temperature readings turned sideways. A legend shows a damage scale. Apparently measured in orderly steps, this scale starts with the most serious problem (“Heating of Secondary O-ring,” which means a primary ring burned through and leaked) and then continues in several ordered steps to “No Damage.” Regrettably, the scale’s visual representation is disordered: the cross-hatching varies erratically from dark, to light, to medium dark, to darker, to lightest—a visual pattern unrelated to the substantive order of the measured scale. A letter-code accompanies the cross-hatching. Such codes can hinder visual understanding.

At any rate, these nine rockets suffered no damage, even at quite cool temperatures. But the graph is not on point, for it is based on test data from “Development and Qualification Motors”—all fixed rockets ignited on horizontal test stands at Thiokol, never undergoing the stress of a real flight. Thus this evidence, although perhaps better than nothing (that’s all it is better than), is not directly relevant to evaluating the dangers of a cold-weather launch. Some of these same temperature numbers for test rockets are found in a pre-launch chart that we saw earlier.

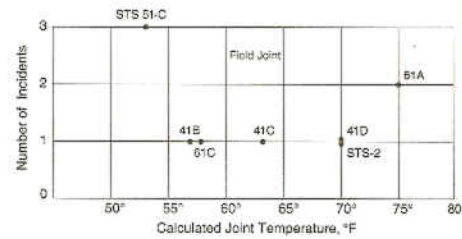
³⁹ Most accounts of the Challenger re-produce a scatterplot that apparently demonstrates the analytical failure of the pre-launch debate. This graph depicts only launches with O-ring damage and their temperatures, omitting all damage-free launches (an absence of data points on the line of zero incidents of damage):

First published in the shuttle commission report (PCSSCA, volume i, p. 146), the chart is a favorite of statistics teachers. It appears in textbooks on engineering, graphics, and statistics—relying on Dalal, Fowlkes, Hoadley, “Risk Analysis of the Space Shuttle: Pre-Challenger Prediction of Failure,” who describe the scatterplot as having a central role in the launch decision. (The commission report does not say when the plot was made.) The graph of the missing data-points is a vivid and poignant object lesson in how not to look at data when making an important decision. But it is too good to be true! First, the graph was *not* part of the pre-launch debate; it was *not* among the 13 charts used by Thiokol and NASA in deciding to launch. Rather, it was drawn *after* the accident by two staff members (the executive director and a lawyer) at the commission as *their simulation* of the poor reasoning in the pre-launch debate. Second, the graph implies that the pre-launch analysis examined 7 launches at 7 temperatures with 7 damage measurements. That is not true; only 2 cases of blow-by and 2 temperatures were linked up. The actual pre-launch analysis was much thinner than indicated by the commission scatterplot. Third, the damage scale is dequantified, only counting the number of incidents rather than measuring their severity. In short, whether for teaching statistics or for seeking to understand the practice of data graphics, why use an inaccurately simulated post-launch chart when we have the genuine 13 pre-launch decision charts right in hand? (On this scatterplot, see Lighthall, “Launching the Space Shuttle Challenger;” and Vaughan, *Challenger Launch Decision*, pp. 382–384.)

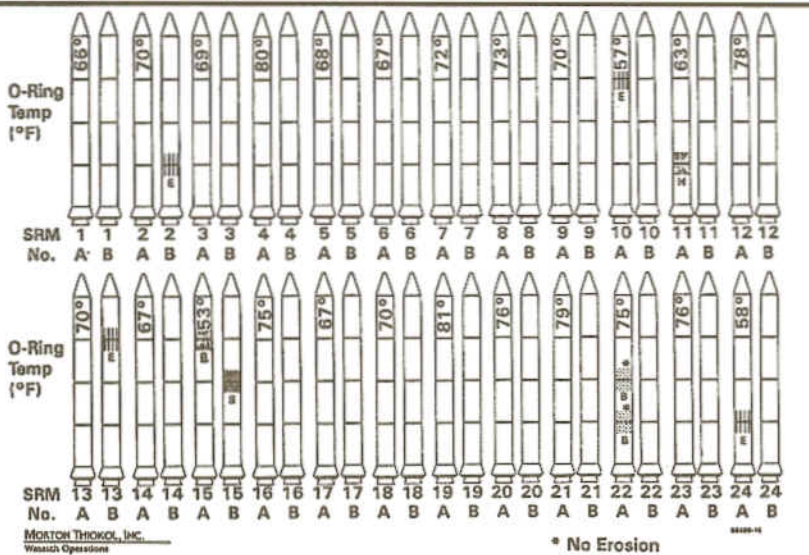
History of O-Ring Damage in Field Joints (Cont)

The second chart in the sequence is most significant. Shown below are the O-ring experiences of all 24 previous shuttle launches, with 48 little rockets representing the 24 flight-pairs:

Rockets marked with the damage code show the seven flights with O-ring problems. Launch temperature is given for each pair of rockets. Like the data matrix we saw earlier, this display contains *all* the information necessary to diagnose the relationship between temperature and damage, if we could only see it.⁴¹ The poor design makes it impossible to learn what was going on. In particular:

⁴¹ This chart shows the rocket pair SRM 4A, SRM 4B at 80°F, as having *undamaged* O-rings. In fact, those rocket casings were lost at sea and their O-ring history is unknown.

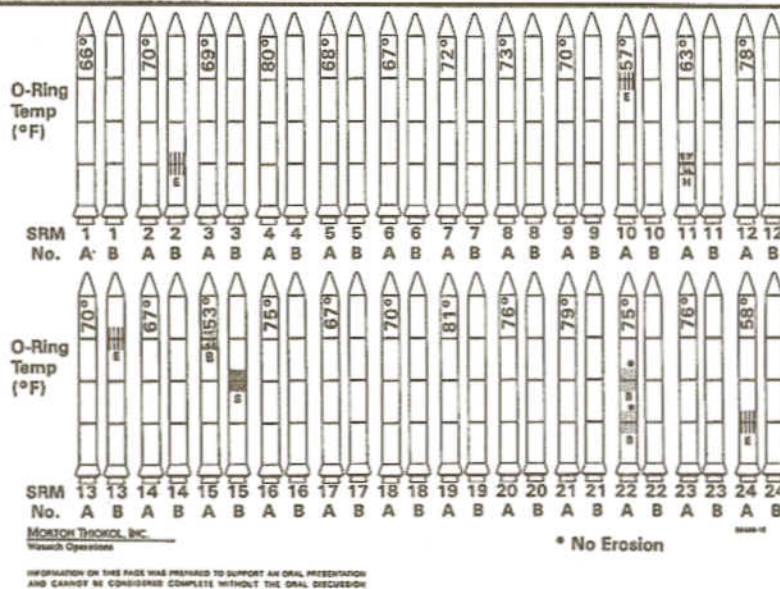
History of O-Ring Damage in Field Joints (Cont)

Chartjunk Good design brings *absolute attention* to data. Yet instead of focusing on a possible link between damage and temperature—the vital issue here—the strongest visual presence in this graph is the clutter generated by the outlines of the 48 little rockets. The visual elements bounce and glow, as heavy lines activate the white space, producing visual noise. Such misplaced priorities in the design of graphs and charts should make us suspicious about the competence and integrity of the analysis. Chartjunk indicates statistical stupidity, just as weak writing often reflects weak thought: “Neither can his mind be thought to be in tune, whose words do jarre,” wrote Ben Jonson in the early 1600s, “nor his reason in frame, whose sentence is posterous.”⁴²

Lack of Clarity in Depicting Cause and Effect Turning the temperature numbers sideways obscures the causal variable. Sloppy typography also impedes inspection of these data, as numbers brush up against line-art. Likewise garbled is the measure of effect: O-ring anomalies are depicted by little marks—scattered and opaquely encoded—rather than being totaled up into a summary score of damage for each flight. Once again Jonson’s Principle: these problems are more than just poor design, for a lack of visual clarity in arranging evidence is a sign of a lack of intellectual clarity in reasoning about evidence.

Wrong Order The fatal flaw is the *ordering* of the data. Shown as a time-series, the rockets are sequenced by date of launching—from the first pair at upper left SRM No. 1 1 to the last pair at lower right 24 24 (the launch immediately prior to Challenger). The sequential order conceals the possible link between temperature and O-ring damage, thereby throwing statistical thinking into disarray. The time-series

chart at left bears on the issue: Is there a time trend in O-ring damage? This is a perfectly reasonable question, but not the one on which the survival of Challenger depended. That issue was: Is there a temperature trend in O-ring damage?

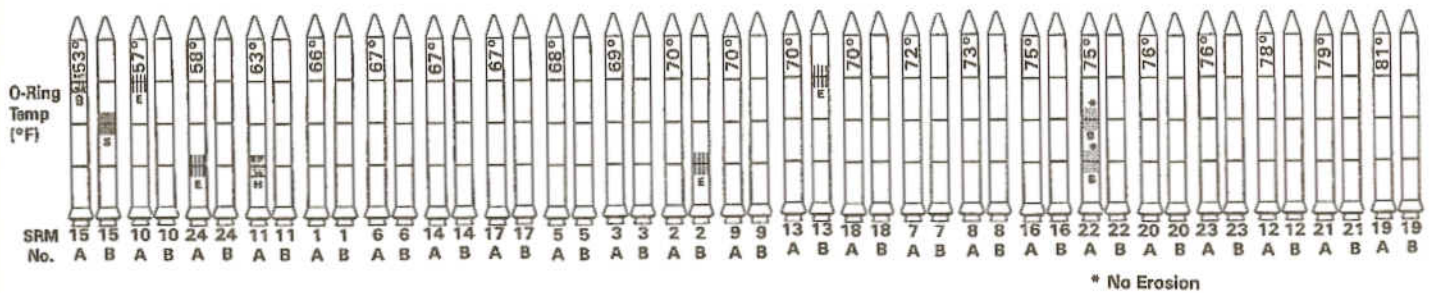
Information displays should serve the analytic purpose at hand; if the substantive matter is a possible cause-effect relationship, then graphs should organize data so as to illuminate such a link. Not a complicated idea, but a profound one. Thus the little rockets must be *placed in order by temperature, the possible cause*. Above, the rockets are so ordered by temperature. This clearly shows the serious risks of a cold launch, for most O-ring damage occurs at cooler temperatures. Given this evidence, how could the Challenger be launched at 29°?

In the haplessly dequantified style typical of iconographic displays, temperature is merely ordered rather than measured; all the rockets are adjacent to one another rather than being spaced apart in proportion to their temperature. Along with proportional scaling—routinely done in conventional statistical graphs—it is particularly revealing to include a symbolic pair of rockets way over at 29°, the predicted temperature for the Challenger launch. Another redrawing:

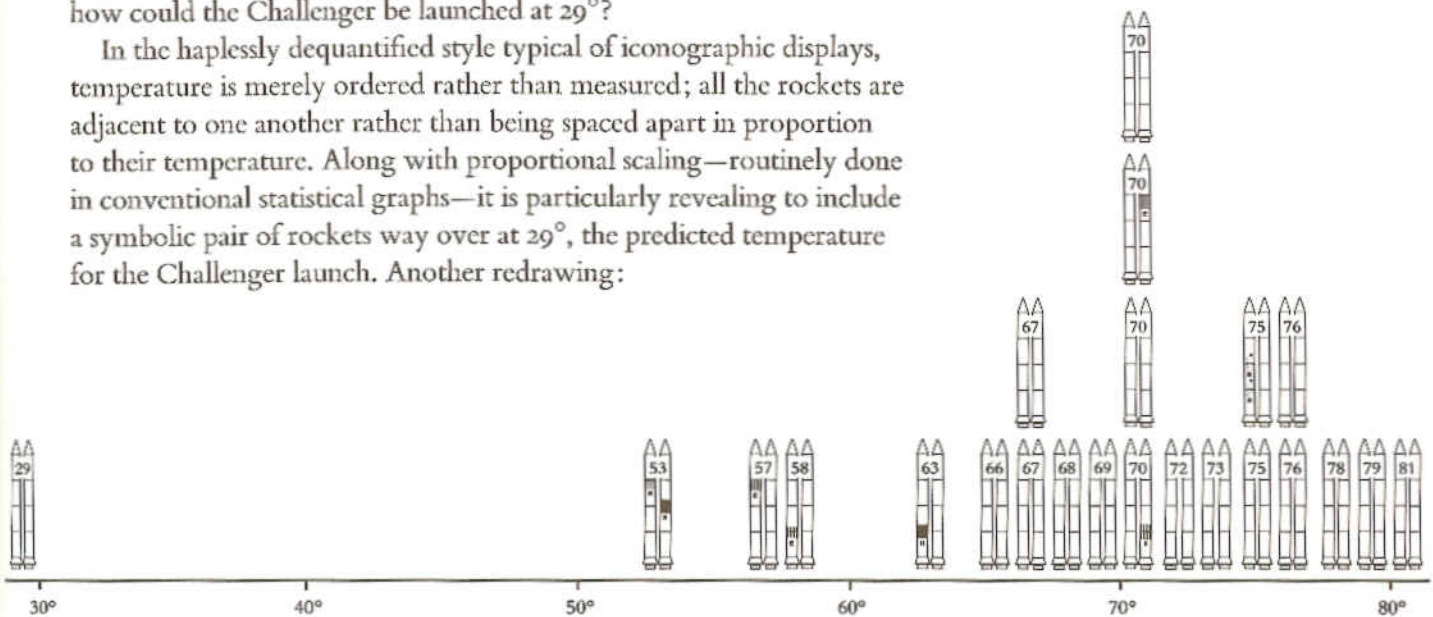
Even after repairs, the pictorial approach with cute little rockets remains ludicrous and corrupt. The excessively original artwork just plays around with the information. It is best to forget about designs involving such icons and symbols—in this case and, for that matter, in nearly all other cases. These data require only a simple scatterplot or an ordered table to reveal the deadly relationship.

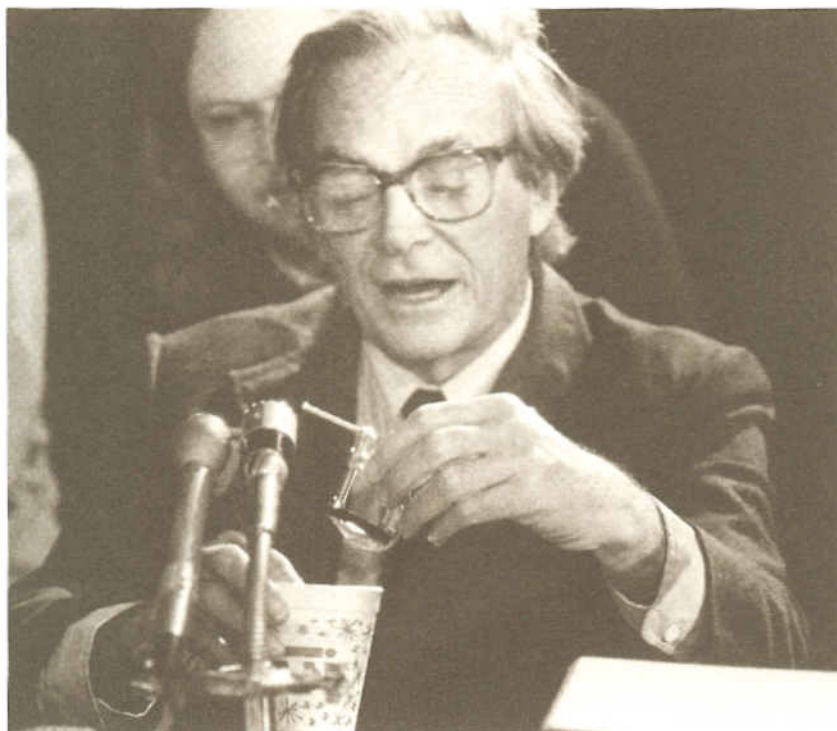
At a meeting of the commission investigating the shuttle accident, the physicist Richard Feynman conducted a celebrated demonstration that clarified the link between cold temperature and loss of resiliency in the rubber O-rings. Although this link was obvious for weeks to engineers and those investigating the accident, various officials had camouflaged the issue by testifying to the commission in an obscurantist language of evasive technical jargon.⁴³ Preparing for the moment during the public hearing when a piece of an O-ring (from a model of the field joint) would be passed around, Feynman had earlier that morning purchased a small clamp at a hardware store in Washington. A colorful theater of physics resulted. Feynman later described his famous experiment:

I take the clamp out, hold it in the air, and loosen it as I talk: "I discovered that when you undo the clamp, the rubber doesn't spring back. In other words, for more than a few seconds, there is no resilience in this particular material when it is at a temperature of 32 degrees. I believe that has some significance for our problem."⁴⁴

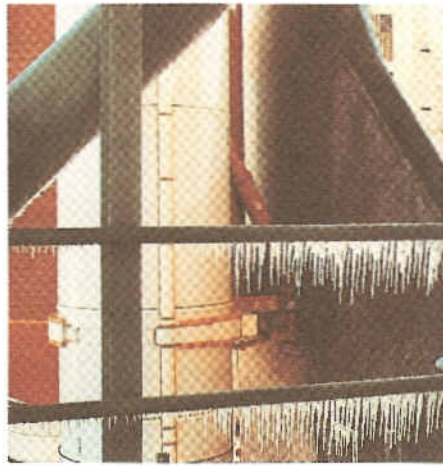
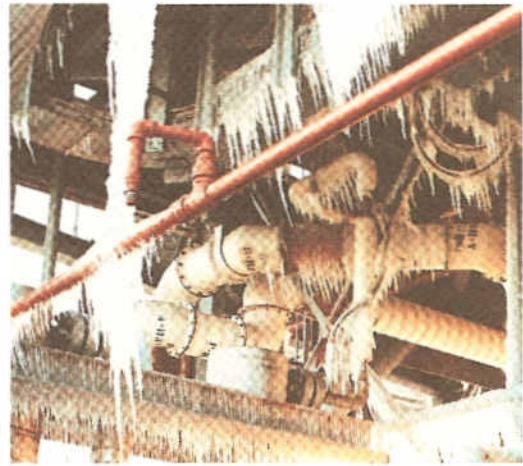
To create a more effective exhibit, the clamped O-ring might well have been placed in a transparent glass of ice water rather than in the opaque cup provided to Feynman. Such a display would then make a visual reference to the extraordinary pre-flight photographs of an ice-covered launch pad, thereby tightening up the link between the ice-water experiment and the Challenger.⁴⁵

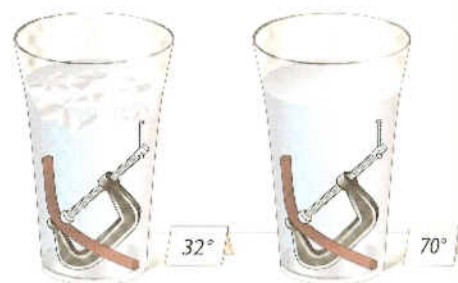
⁴⁸ Feynman was aware of the problematic experimental design. During hearings in the afternoon following the ice-water demonstration, he began his questioning of NASA management with this comment: "We spoke this morning about the resiliency of the seal, and if the material weren't resilient, it wouldn't work in the appropriate mode, or it would be less satisfactory, in fact, it might not work well. I did a little experiment here, and *this is not the way to do such experiments*, indicating that the stuff looked as if it was less resilient at lower temperatures, in ice." (PCSSCA, volume IV, pp. 739-740, transcript, emphasis added.) Drawing of two-glass experiment by Weilin Wu and Edward Tufte.
